Richmond Refinery LPS Bulletin-Reliability

Alky- V-1421 Piping Failure

(3/9/2012)

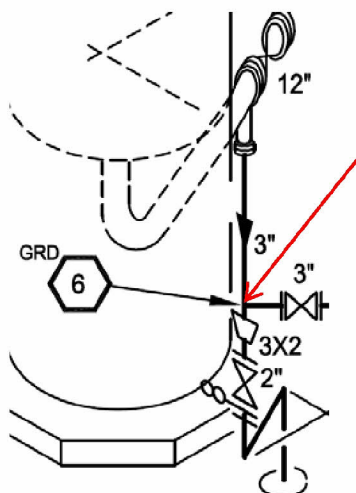
Isometric drawing showing location of failure. New Grid UT inspection point #6 is now active.

- 1) The failure occurred due to under deposit corrosion located on a dead leg section of piping from original 1995 installation. The failure occurred at a tee branch connection on the dead leg piping. The tee surface collected deposits as they fell from above.
- 2) There was no inspection monitoring point on the tee to monitor for under deposit corrosion due to the dead leg condition of the piping.
- 3) The piping circuit was not placed on appropriate inspection frequency per API 570 in the study performed in 2000 for the refinery. The piping was classified as a Class III section of piping and should be classified as a Class I due to light end hydrocarbons in the system.
- 4) Radiographic examination was performed on this piping system in the past, but not at the tee location where the failure occurred.

- 1) Review piping isometrics so that the proper API 570 classification will be assigned to this system. This action will determine the appropriate frequency for the inspection(s), the number of inspections conducted, and the required number of inspection monitoring points.
- 2) Review inspection plans for piping to verify that the appropriate inspection technique is being used and the proper inspection points are being evaluated based on the type of failure that may occur or could be expected in that system.
- 3) Install the block valve just off the main 12" line from V-1421 to reduce the length of dead leg on this piping during the next S/D.
